ERDC/CHL TR-01-26

## **Impacts of Navigation Channel Maintenance Dredging on the Coastal Processes of Chatham, Massachusetts**

Donald K. Stauble

September 2001

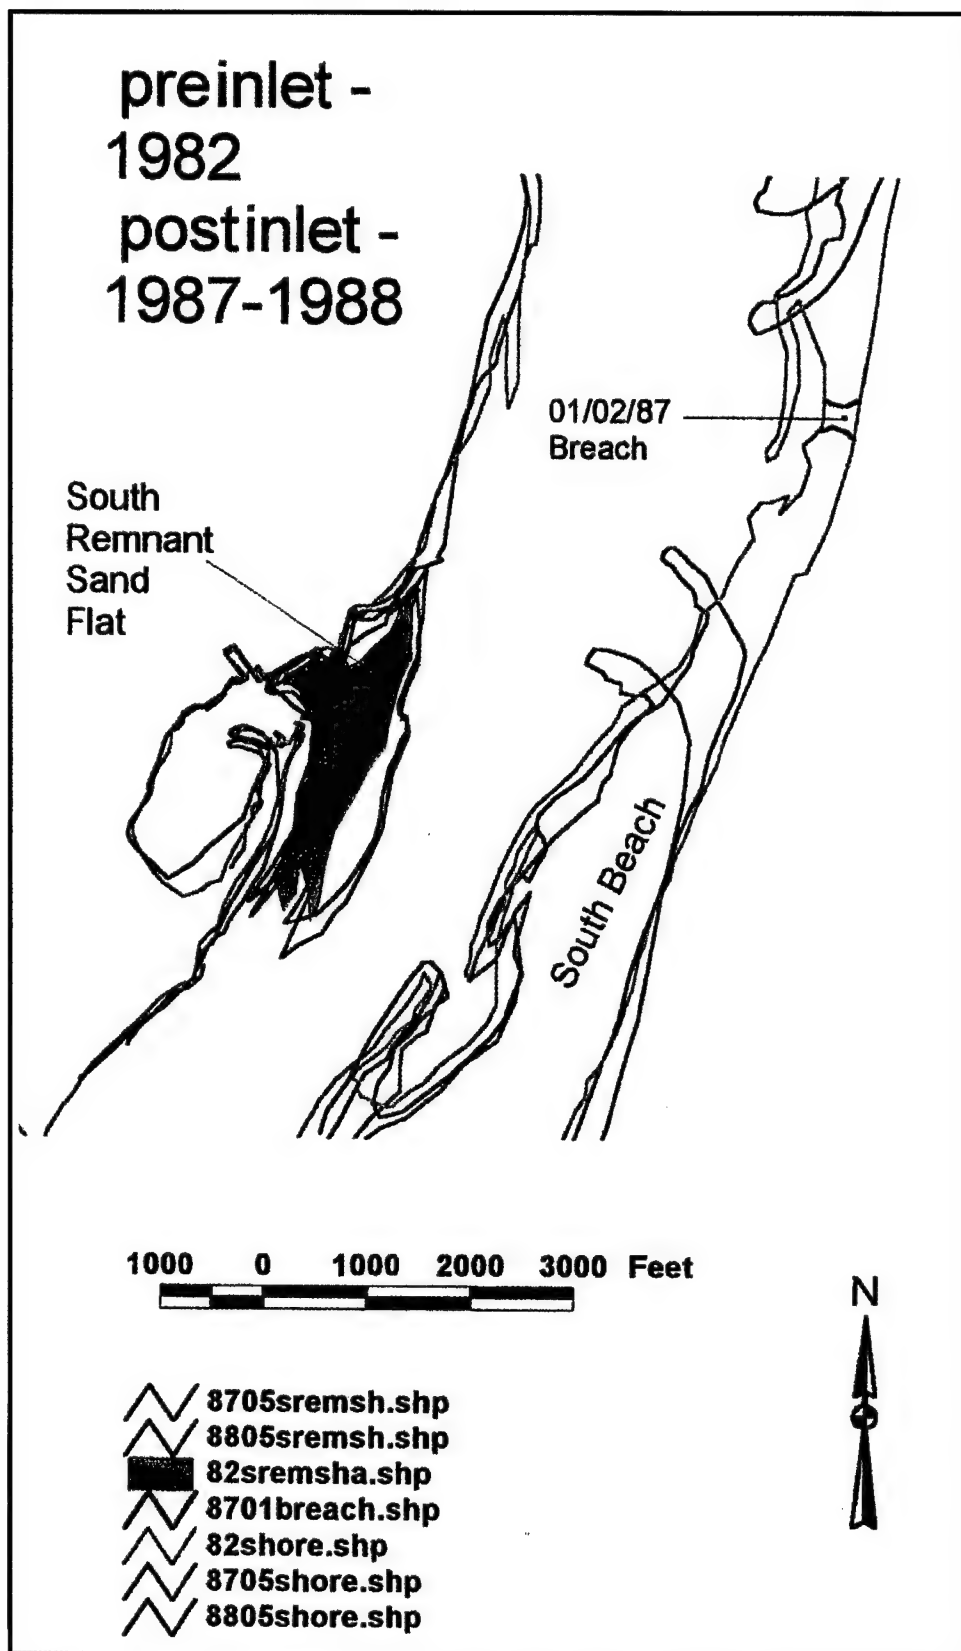
Figure 38. Map of area change in remnant south sand flat. Solid area shows pre-inlet remnant shoal incorporated into the remnant south sand flat

Another preinlet shoal was located south of Chatham Lighthouse near a marina entrance and the spit to Morris Island. Figure 38 shows the location of the remnant south sand flat relative to the south remnant shoal/south flood shoal

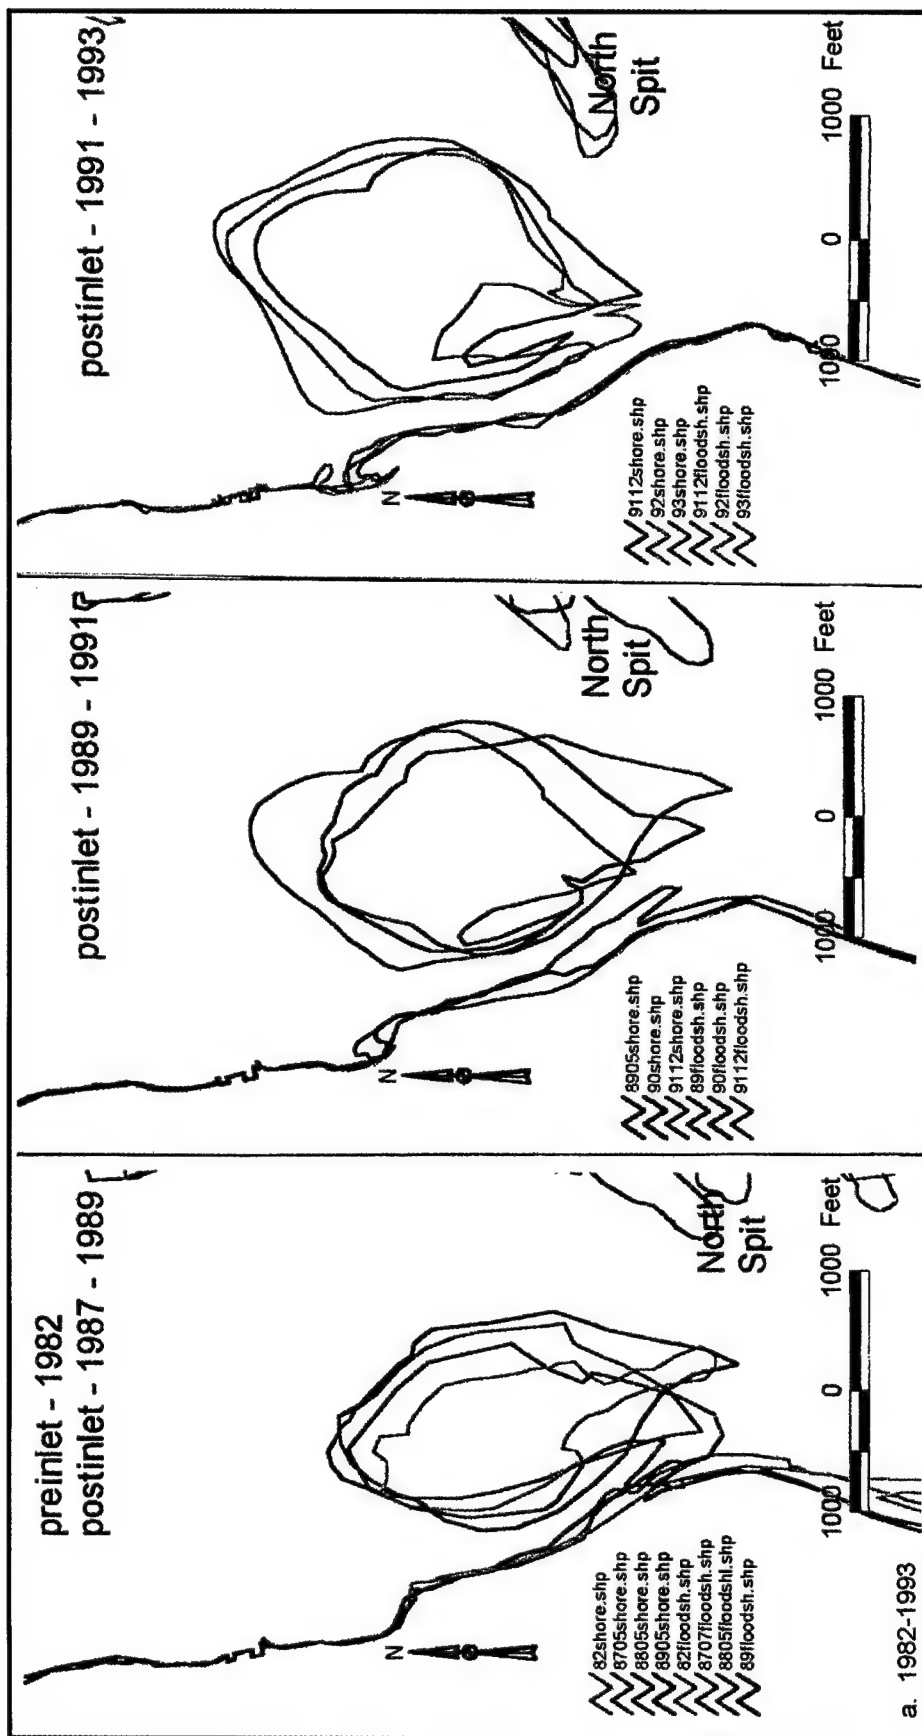
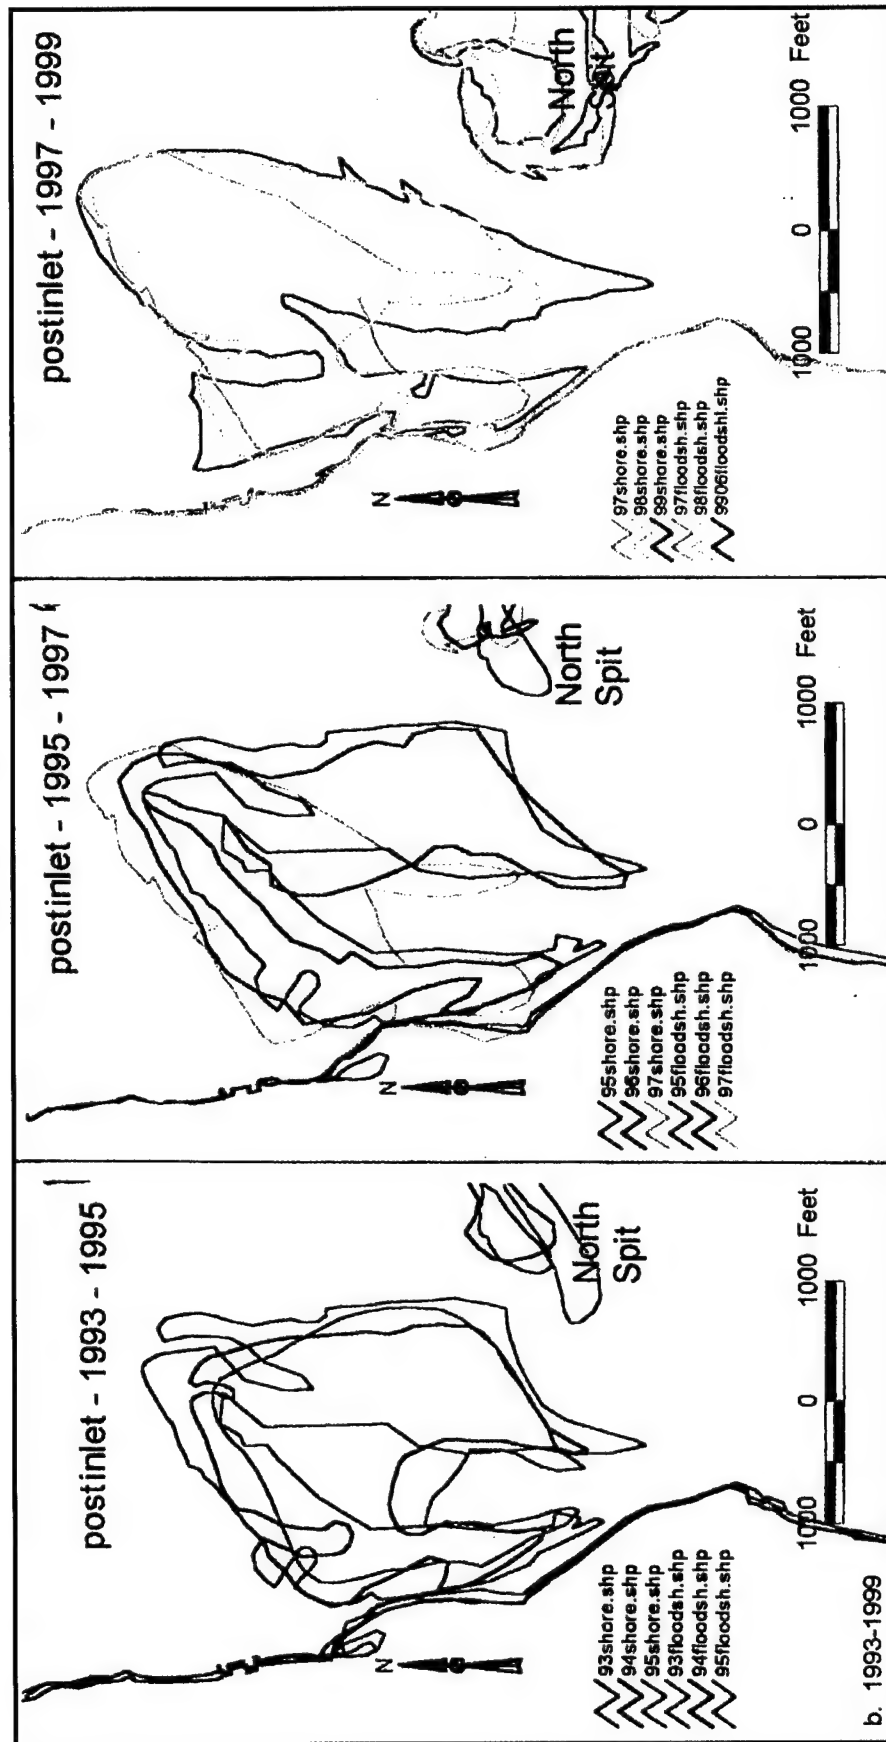
Figure 44. Map of change in north flood shoal (Continued)

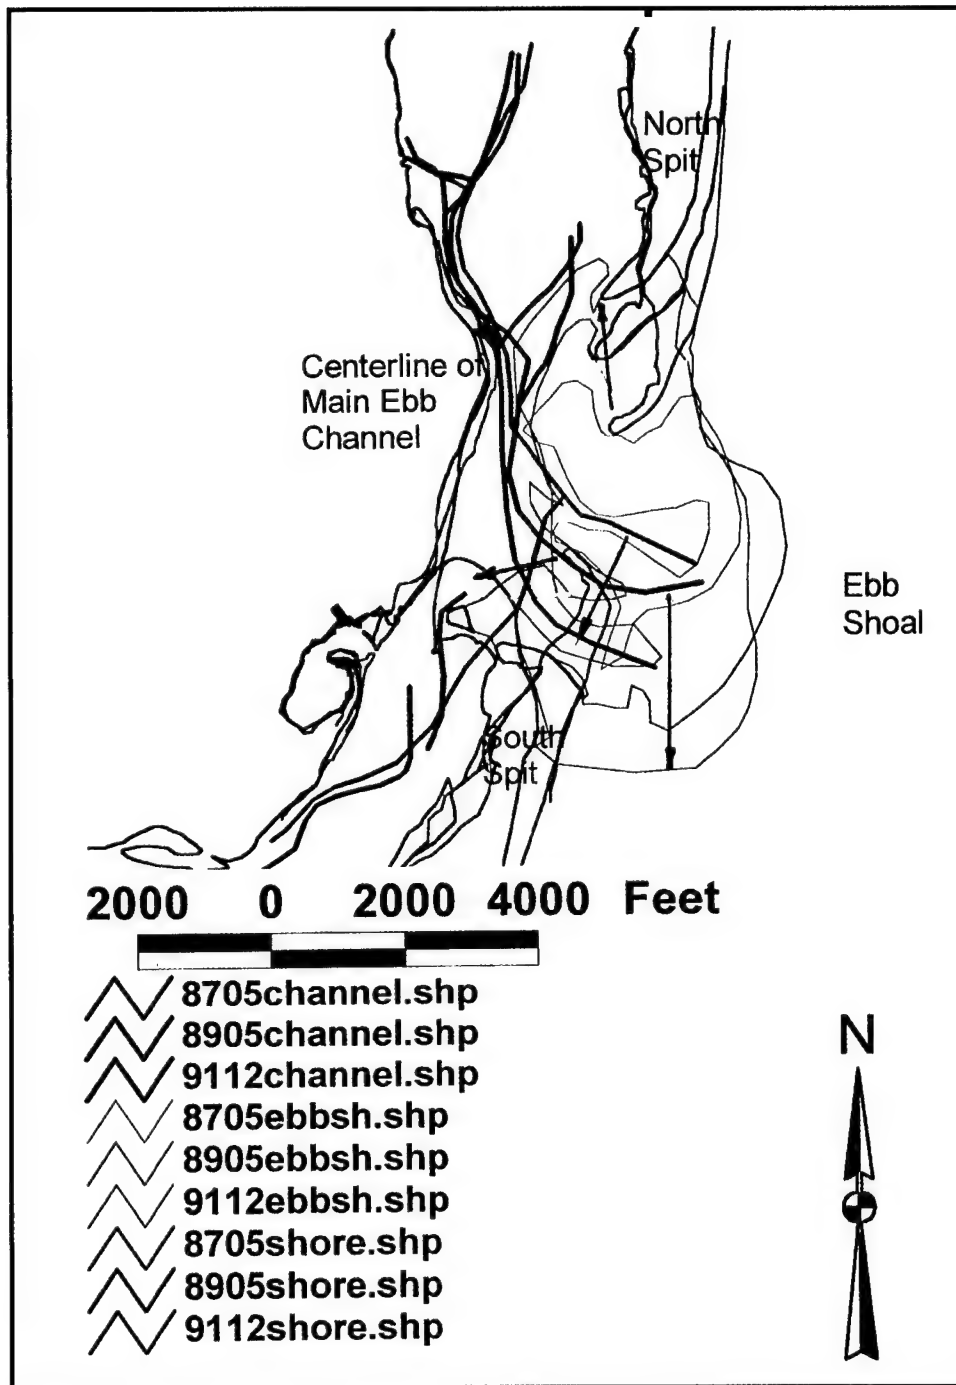
Figure 47. Net changes in main ebb channel, ebb shoal edge, and north and south spits from 1987 to 1991

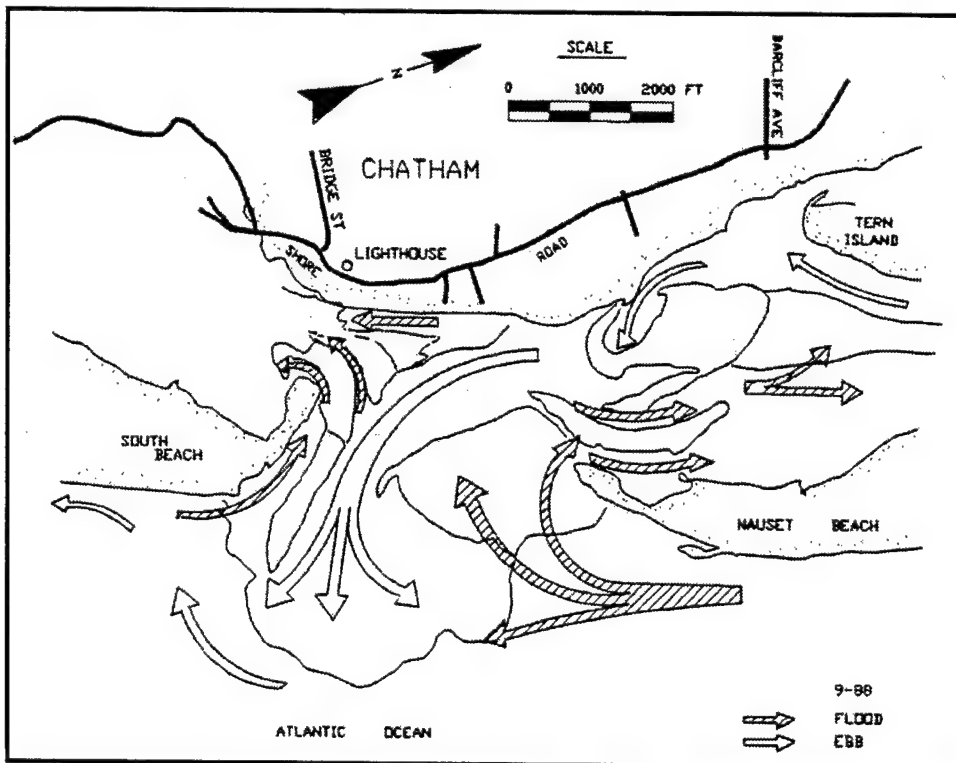
Figure 48. Sediment transport pathways at Chatham Inlet based on morphology from September 1988 (Liu et al. 1993)

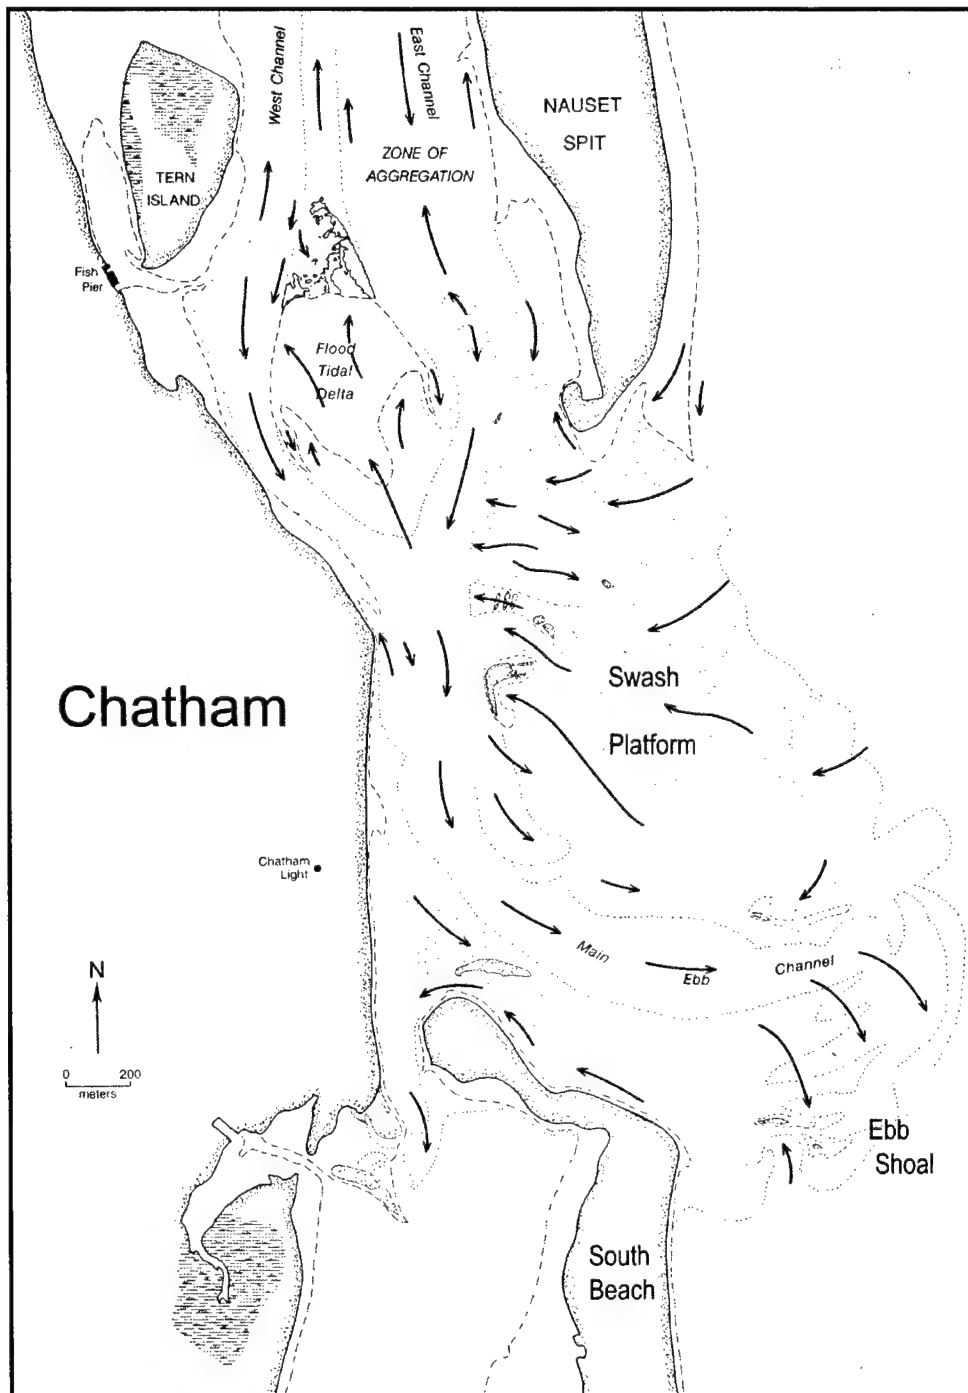
Figure 49. Detailed sediment transport pathways from summer 1990 (after Fitzgerald and Montello 1993)

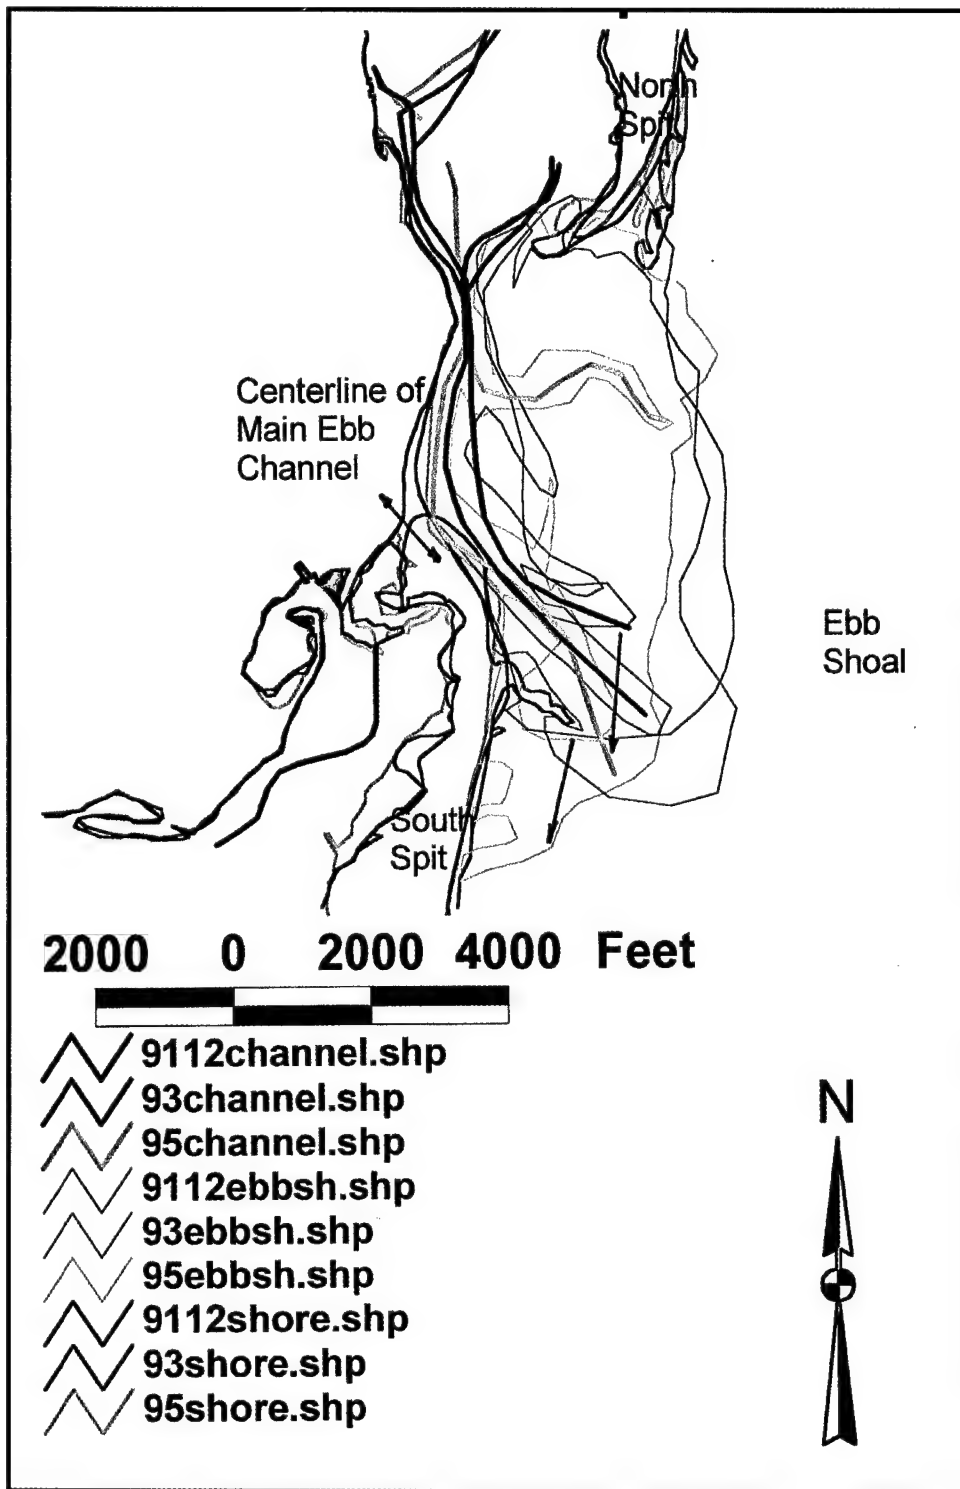
Figure 50. Net changes in main ebb channel, ebb shoal edge, and north and south spits from 1991 to 1995

With the welding of South Beach to the mainland in 1992, the circulation and predominant sediment transport was restricted to north Chatham Harbor and Pleasant Bay. Net changes in the main ebb channel, ebb shoal edge, and north and south spits from 1991 to 1995 are summarized in Figure 50. The ebb shoal

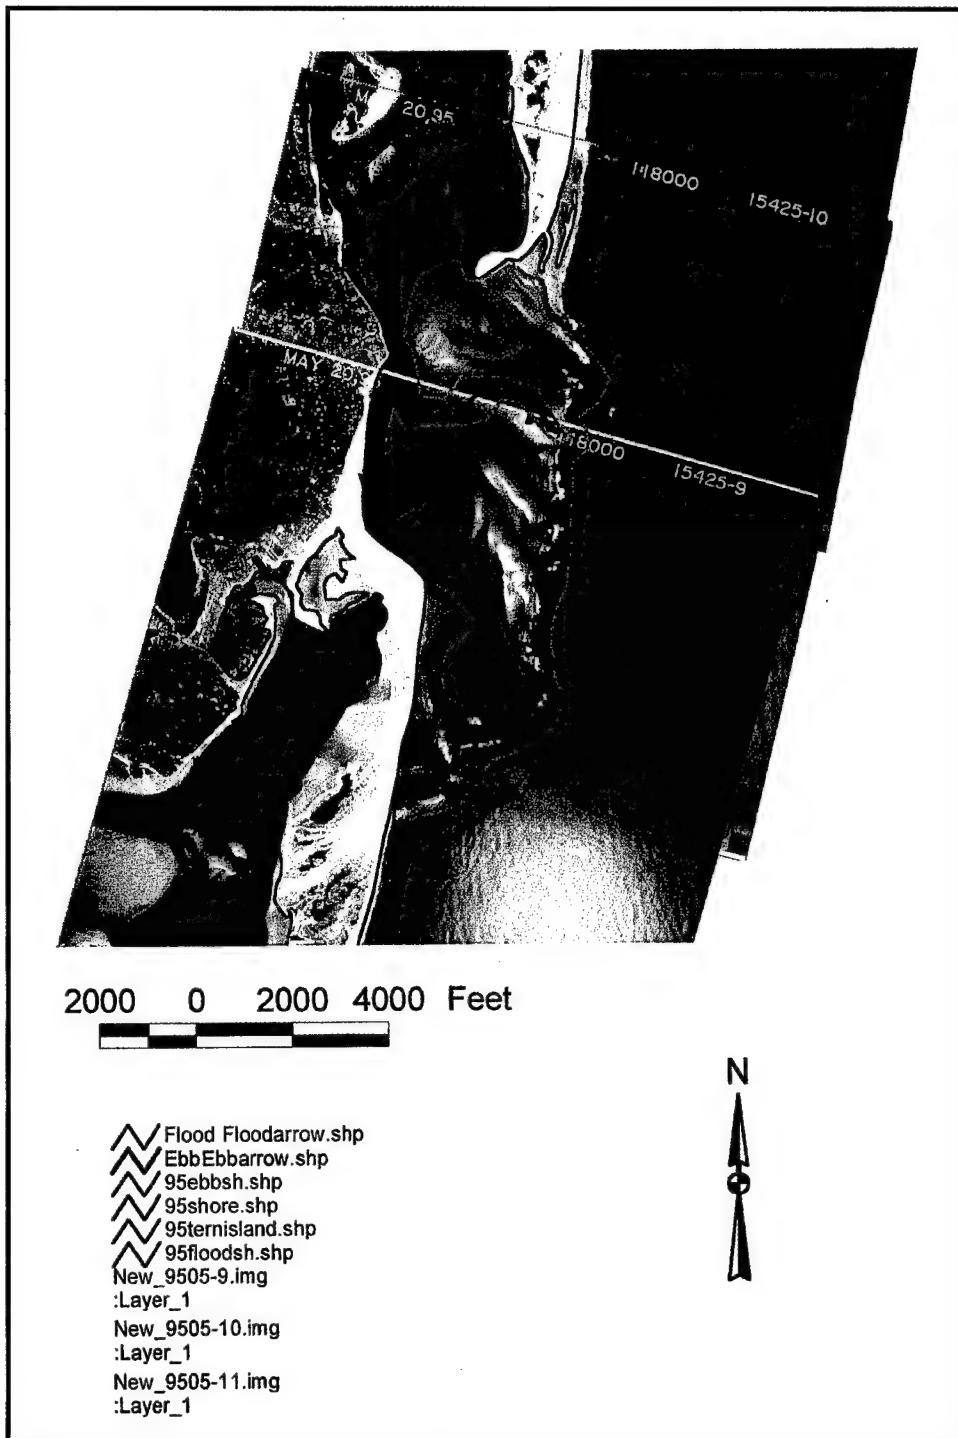
Figure 51. Sediment transport pathways based on morphology from May 1995

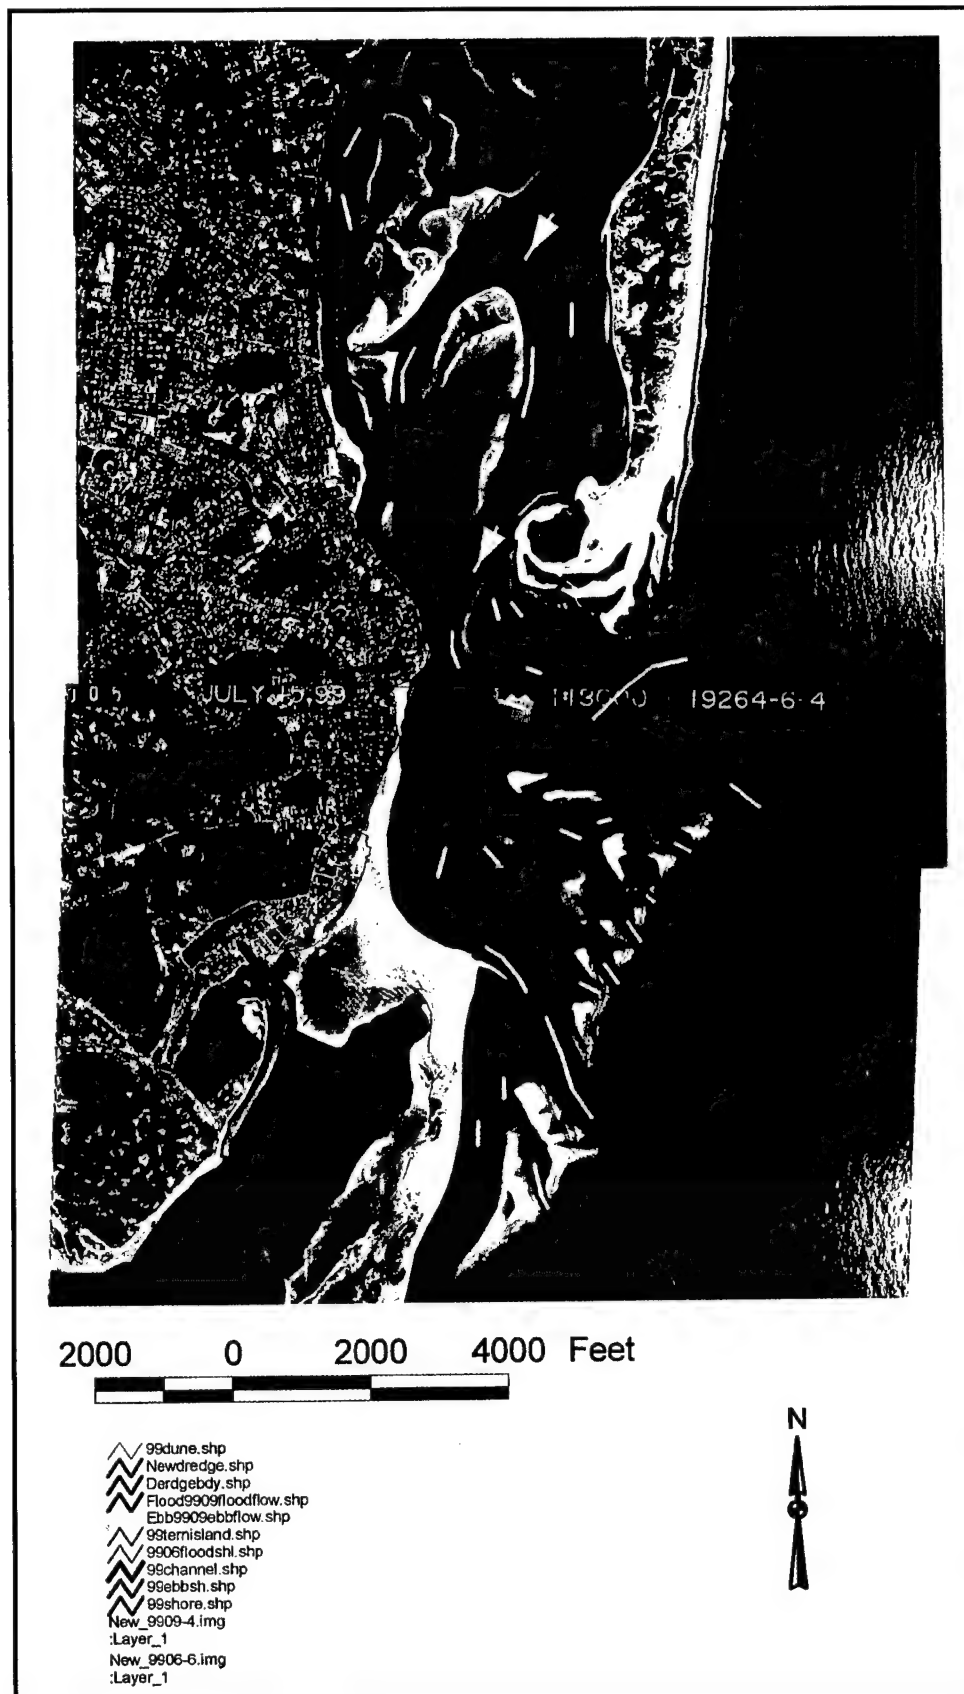
Figure 53. Sediment transport pathways based on morphology from July 1999

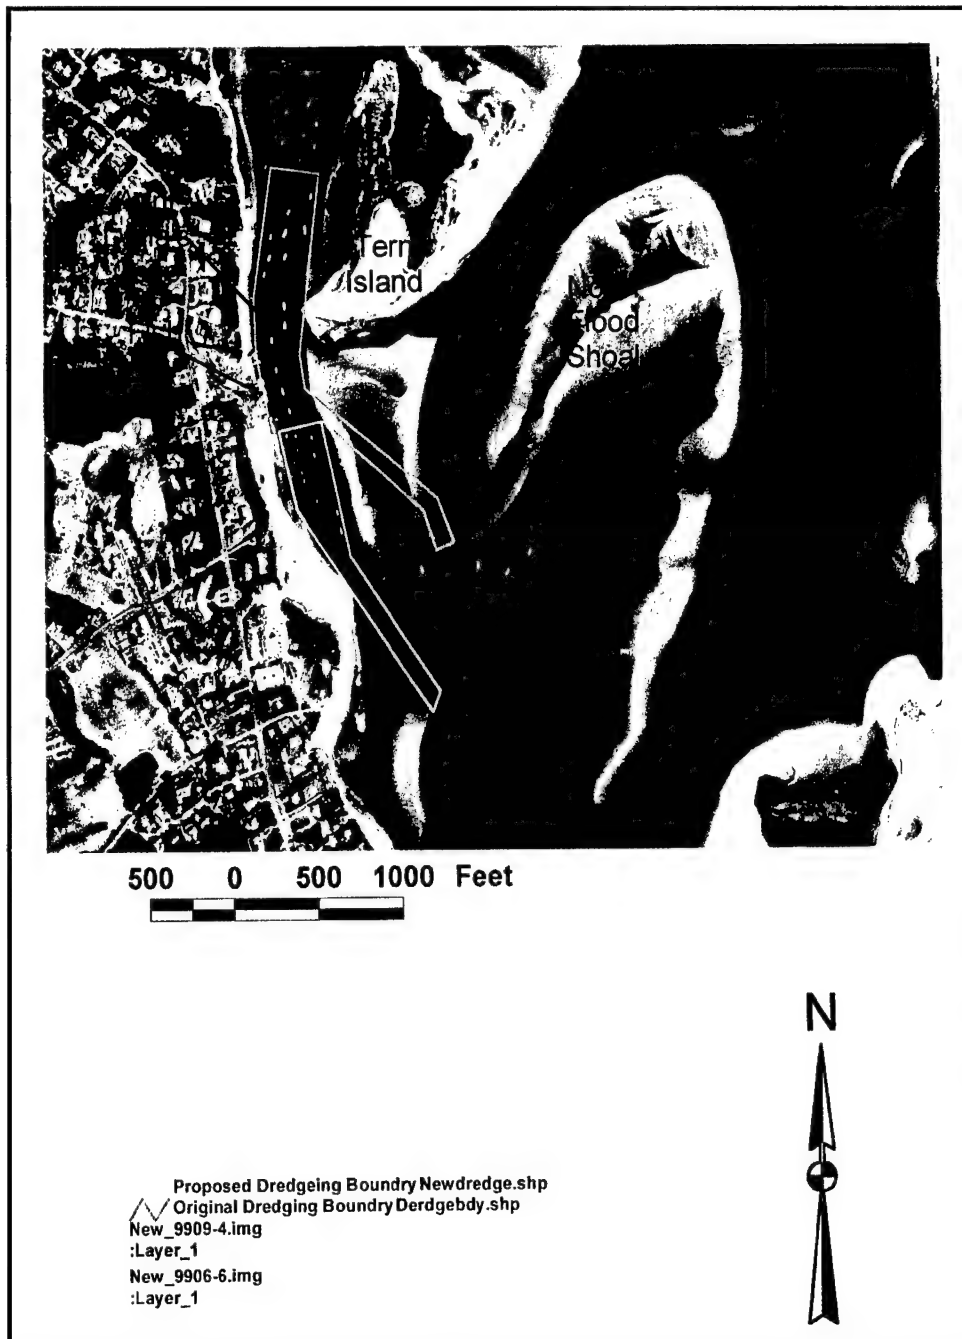
Figure 54. Previous boundaries from 1994/95 dredging and proposed new orientation of dredging boundaries based on current morphodynamics

The maintenance of navigation channels at Aunt Lydia's Cove will continue to be a challenge. It is recommended that in the short-term, dredging of the west ebb spit of the flood shoal be continued in its general location as shown in Figure 54. A re-examination of the orientation will be needed after the west flood channel re-establishes itself and the sand in the detached western part of the flood shoal takes on its own morphology.

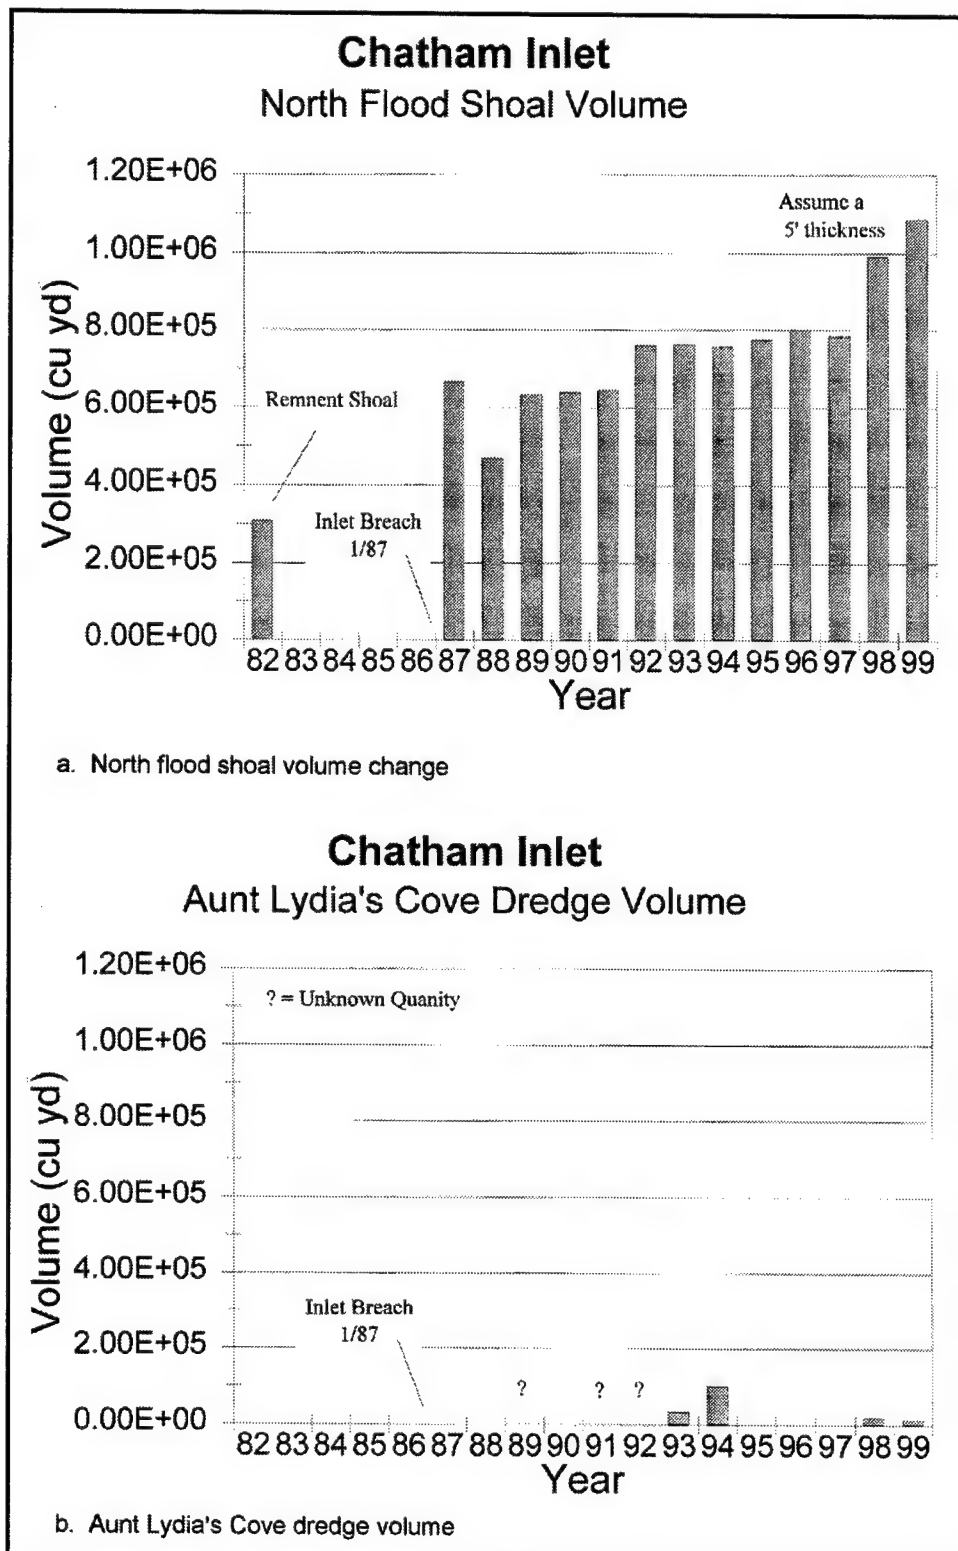
Figure 55. Comparison of north flood shoal volume change with volume of dredged material from Aunt Lydia's Cove (entrance channel and anchorage)

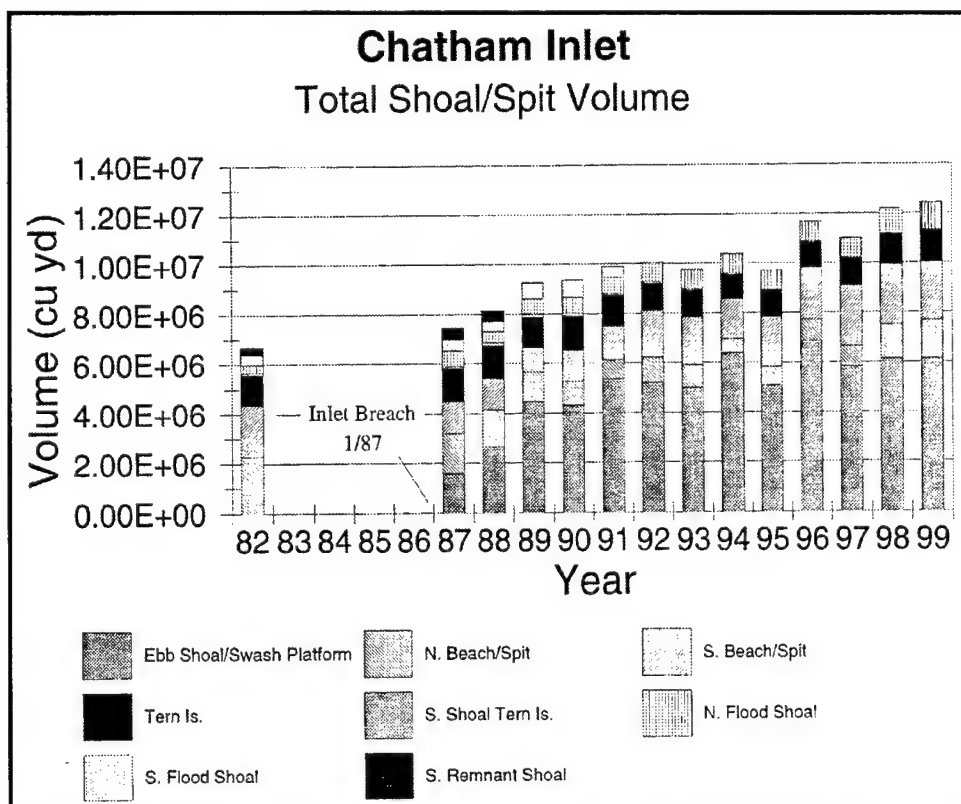
Figure 56. Total estimated volume of sediment in various morphologic units at Chatham Inlet from preinlet to 1999

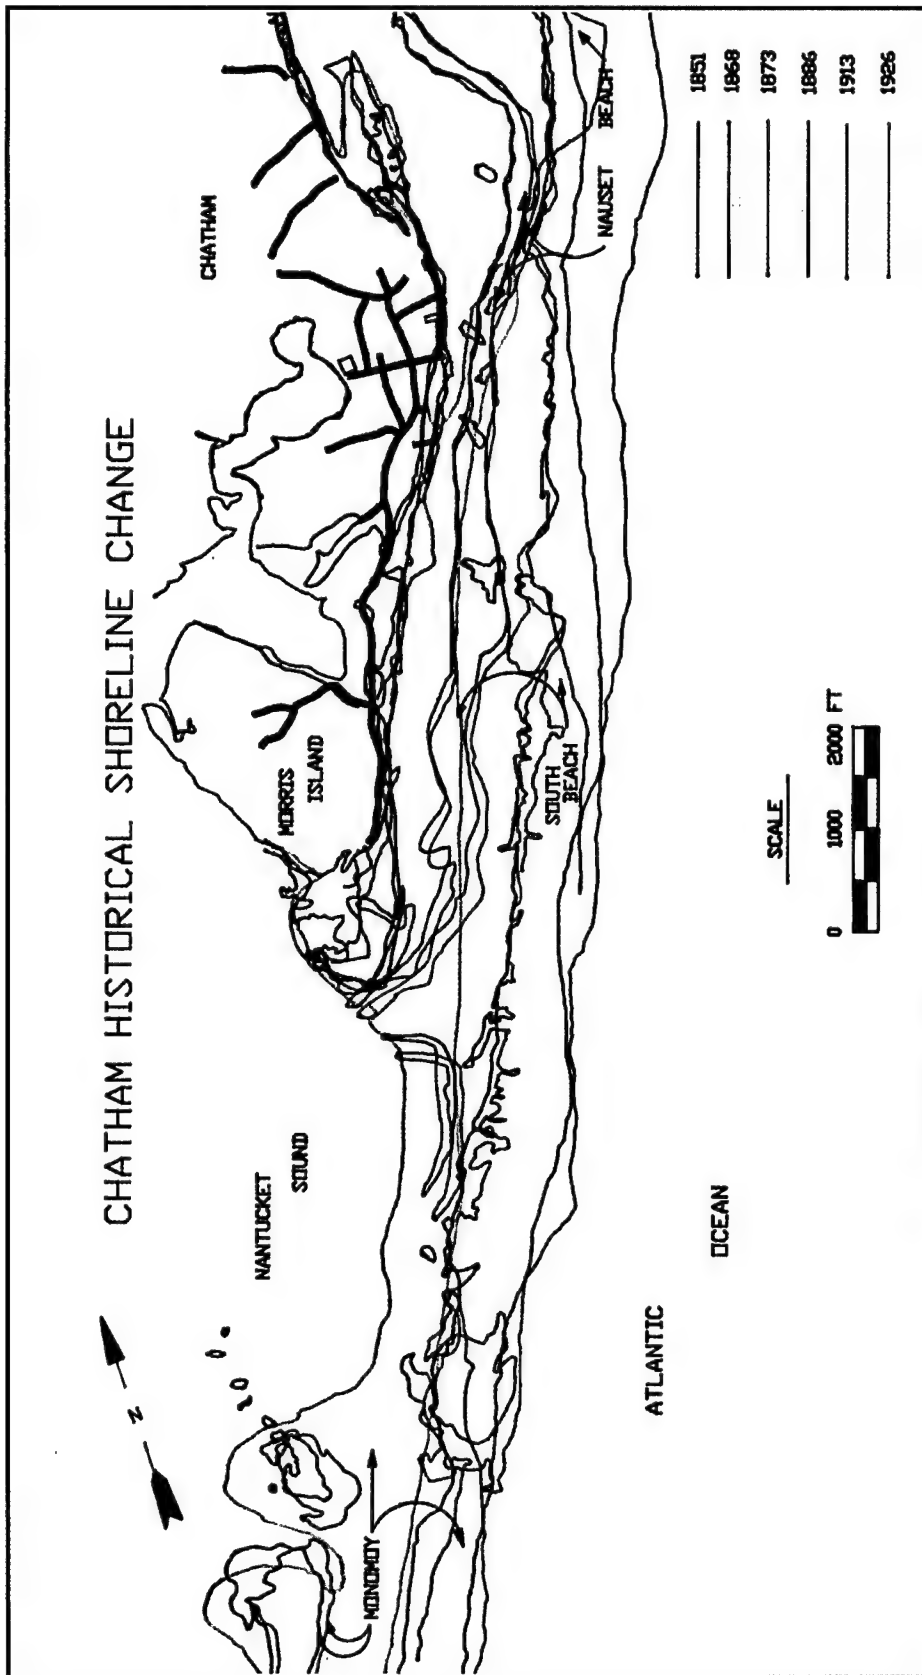
Figure 57. Historic shoreline change from last inlet breach cycle (1851-1926)

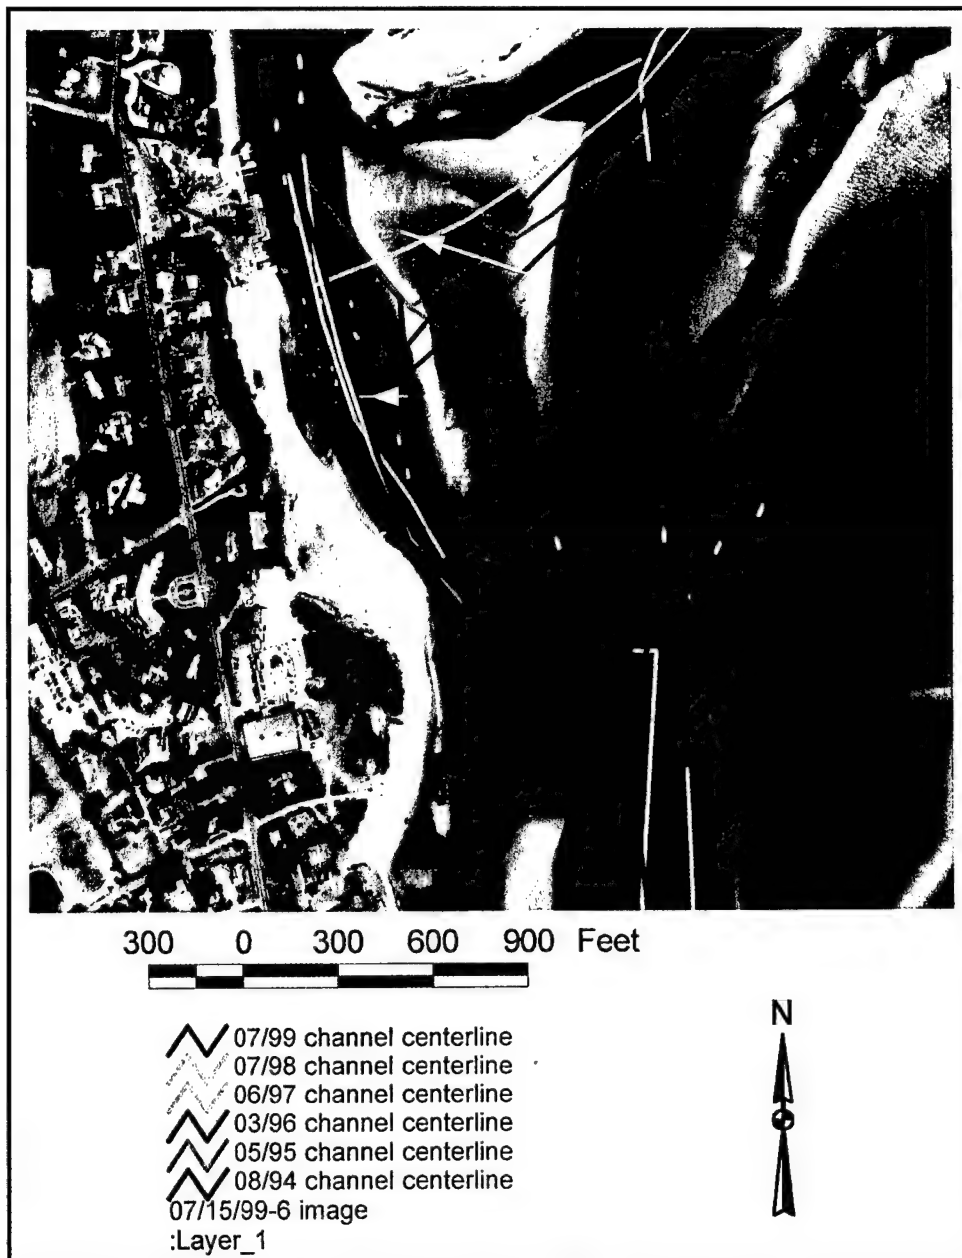
Figure 60. Evolution of Aunt Lydia's Cove entrance channel 1994-1999
